REPORT NO. 710/409

BALLISTIC AND METALLURGICAL PROPERTIES
OF HIGH ALLOY FACE HARDENED ARMOR PLATE
MADE BY THE PHURMELT PROCESS

February 11, 1942

WATERTOWN ARSENAL
WATERTOWN, MASS.

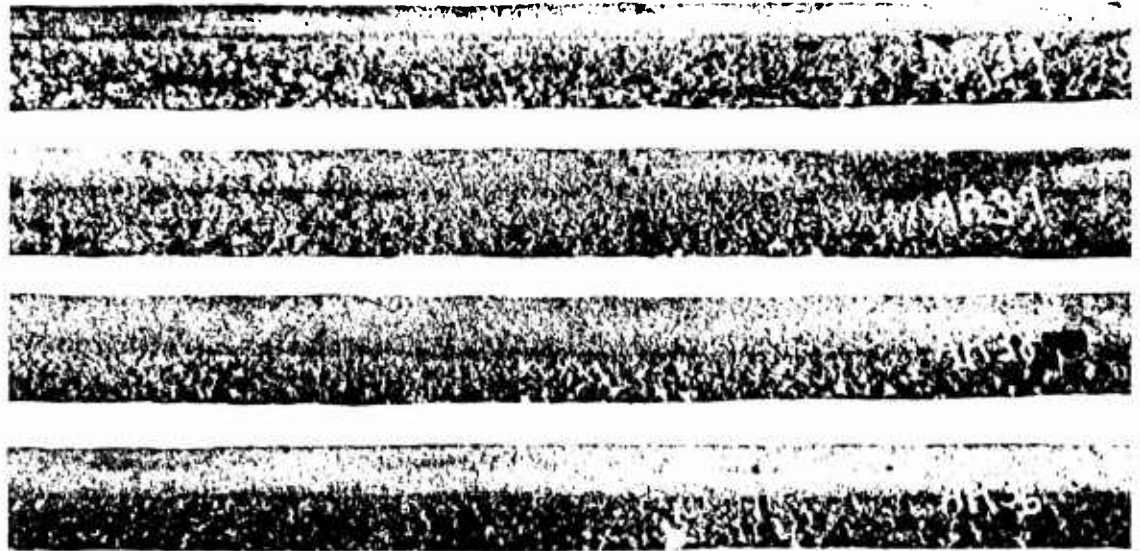
Figure 3MacrostructureDeep EtchPlates AR36, AR37, AR38, and AR39

Each of the plates submitted shows practically equal thicknesses of base metal and armor plate. The junction between the layers appears to be sound and uniform. In the hard zone, quite prominent etched-out segregates are found.

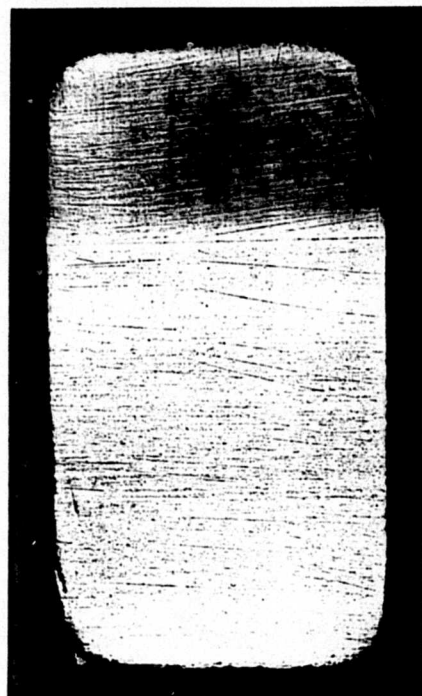
Figure 4

The hard surface layer had a uniform structure. The steel base only showed a trace of banding. A sharp line of demarcation is observed between the hard surface and the steel base.

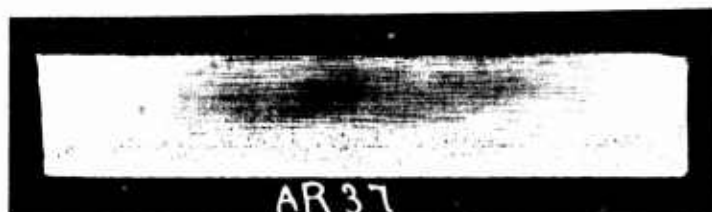
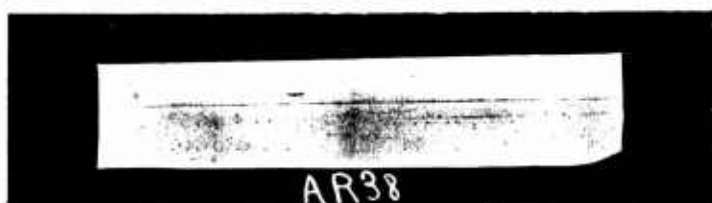
Figure 6

Junction line between hard face and core evident. No pronounced banding. Indication of small defect near junction of hard surface layer and steel base.

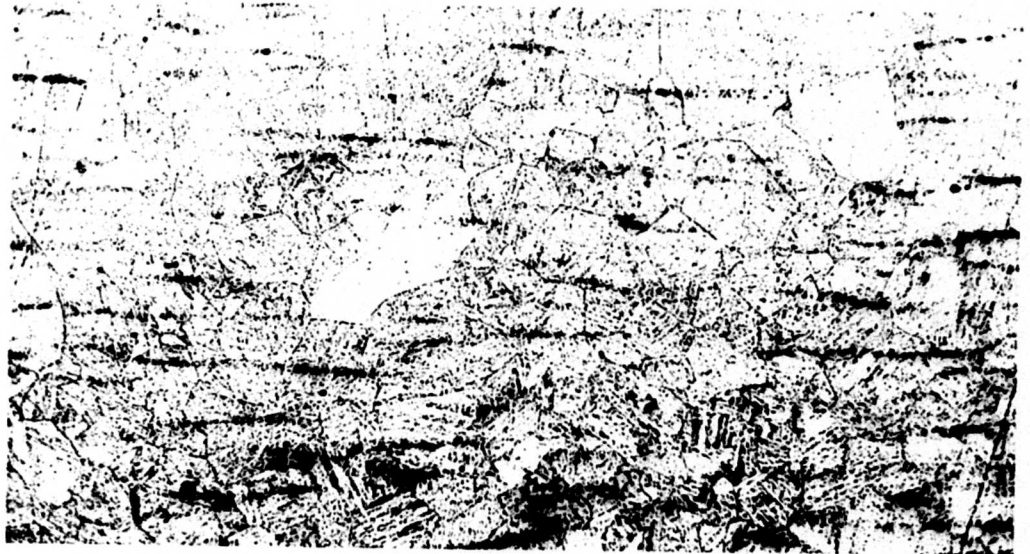
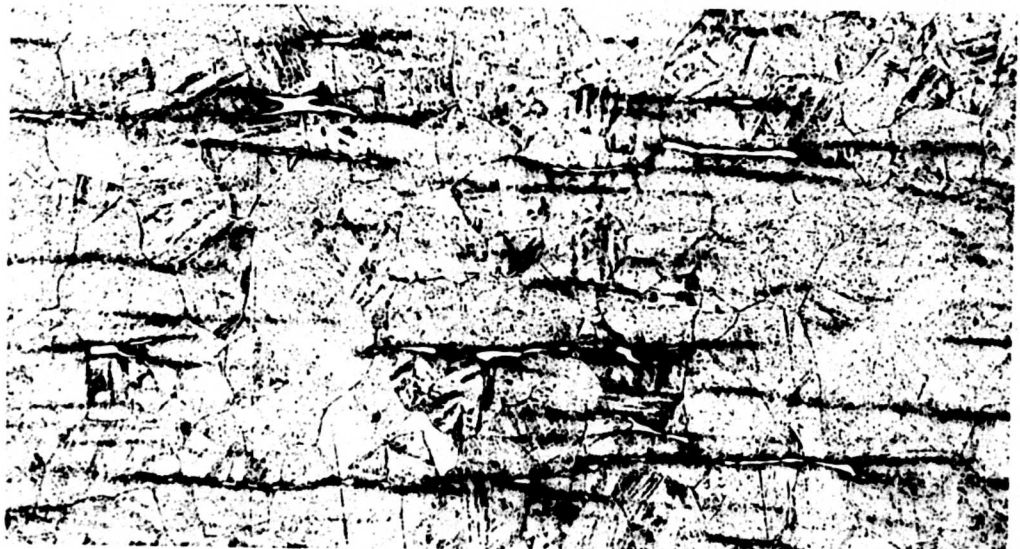
Figure 9Microstructure

- a. Typical microstructure of hard surface layer of plate AR30.
Etched in Vilella's Reagent X100 MA-3163
- b. Typical structure of base metal side of junction between base metal and top layer of plate AR30.
Etched In Vilella's Reagent X100 MA-3161
- c. Typical microstructure of low carbon steel base of plate AR30.
Etched in Vilella's Reagent X100 MA-3162

In most of the samples there is a gradual transition in the microstructure of the relatively high carbon surface to the low carbon rear face. (See Figures 9, 12, 14, and 15.) In the case of one section of plate AR30 this was not true. A sharp line of demarcation between the hard surface and soft back was detected. (See Figure 10.)

In the high carbon face of plates AR30, AR35, AR36, and AR39 considerable carbide banding was evident. (See Figures 9a, 11a, b, c, 12a, 13a, 15a, and 16c.) This banding was less noticeable in plates AR37, and AR38. (See Figure 14a.) In plate AR35, evidence of a wedge shaped ferrite streak is present in the hard surface layer. (See Figure 13b.) A prominent band of carbide is evident in the hard surface layer of plates AR36 and AR39. This band runs in the center of the layer, parallel to the surface of the sheet. (See Figure 18a.)

In the low carbon backs of the plates AR30, AR35, AR36, AR37, AR38, and AR39 the ferrite pools occur in distinct bands, an example of which is shown in Figure 9b. There is evidence of some decarburization on the hard surface of the plates examined as noted below:

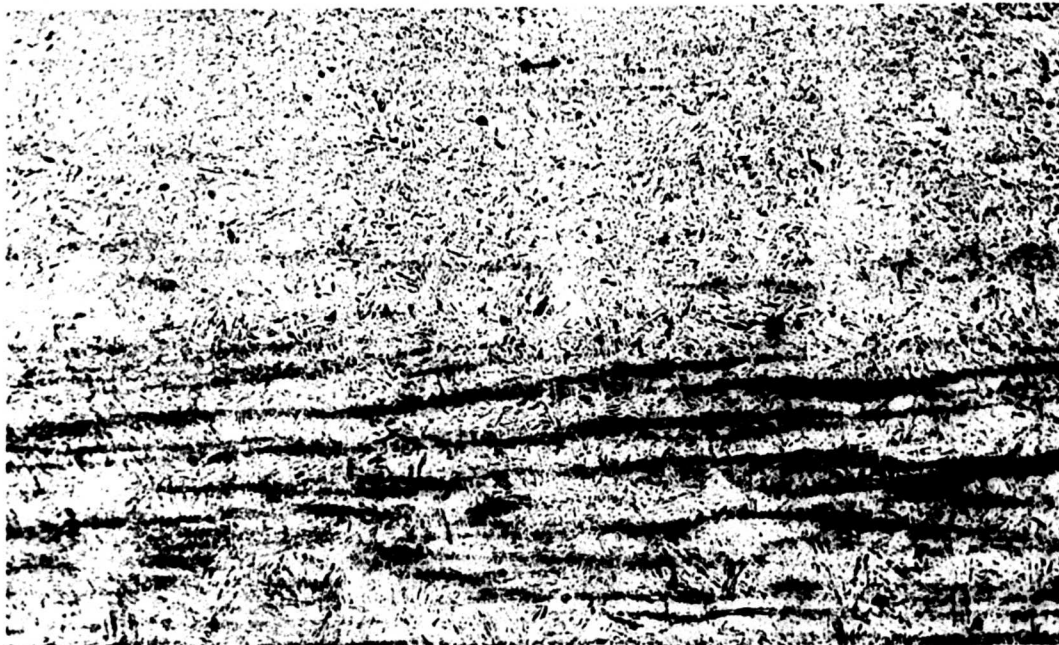
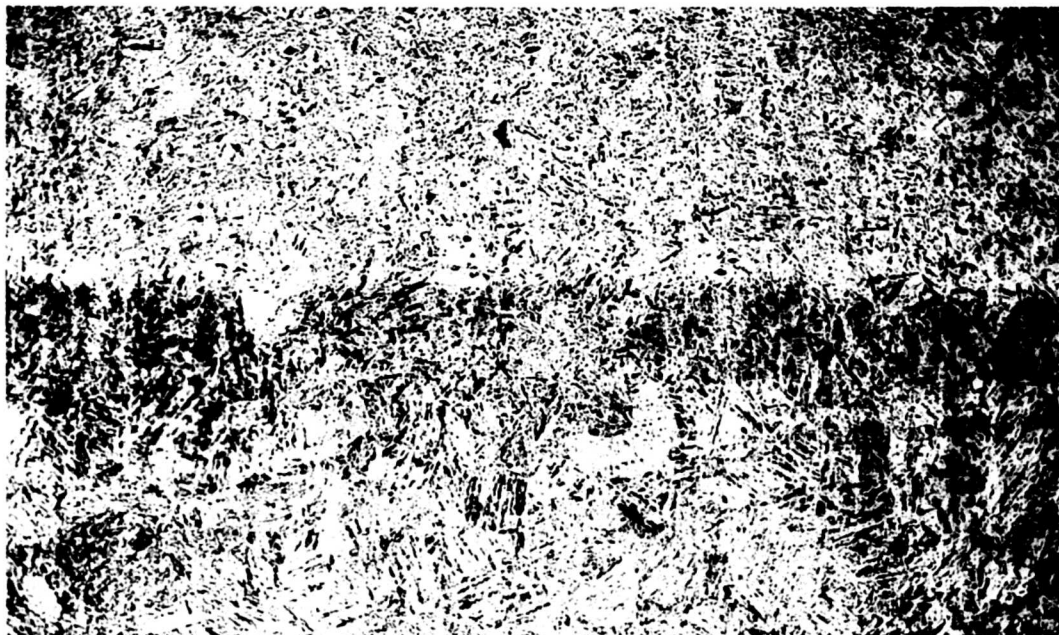
Figure 10

- a. Microstructure of junction of hard case and soft back
of another section in Plate AR30.

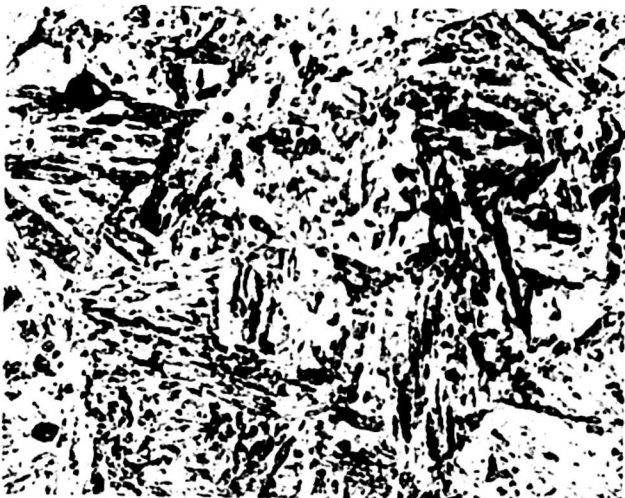
Figure 11Microstructure

- a. Microstructure of hard surface of Plate AR30, 0.7 mm. below surface.

- e. Same as above. Microstructure of steel base.

Etched in Marble's Reagent X1000 MA-3175

a. Pronounced bands of carbides and some grain boundary carbides in the hard surface layer. (See Figures 11a, b, 16a, b, and 17a, and 18e.)

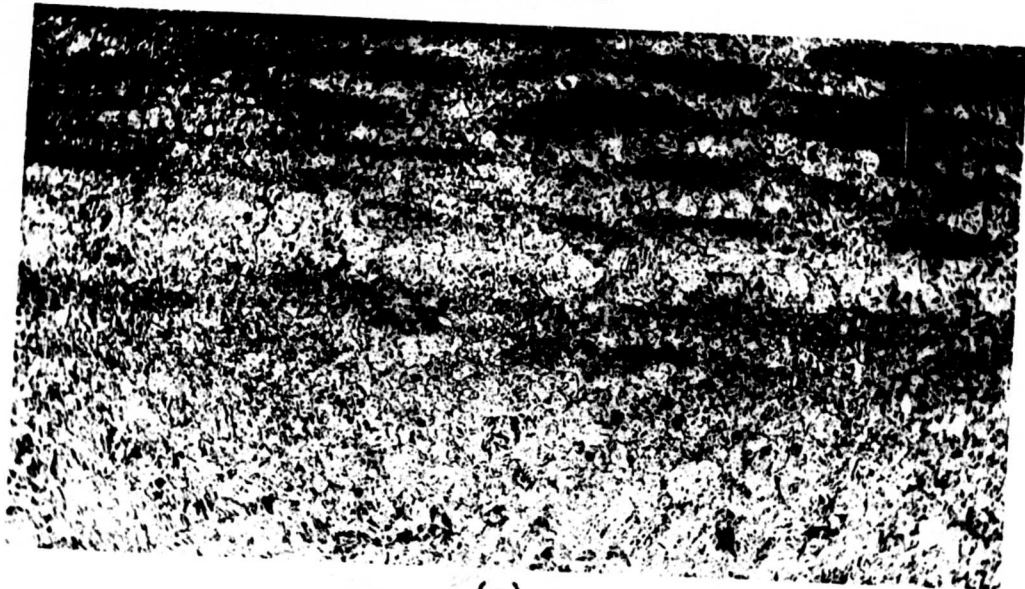
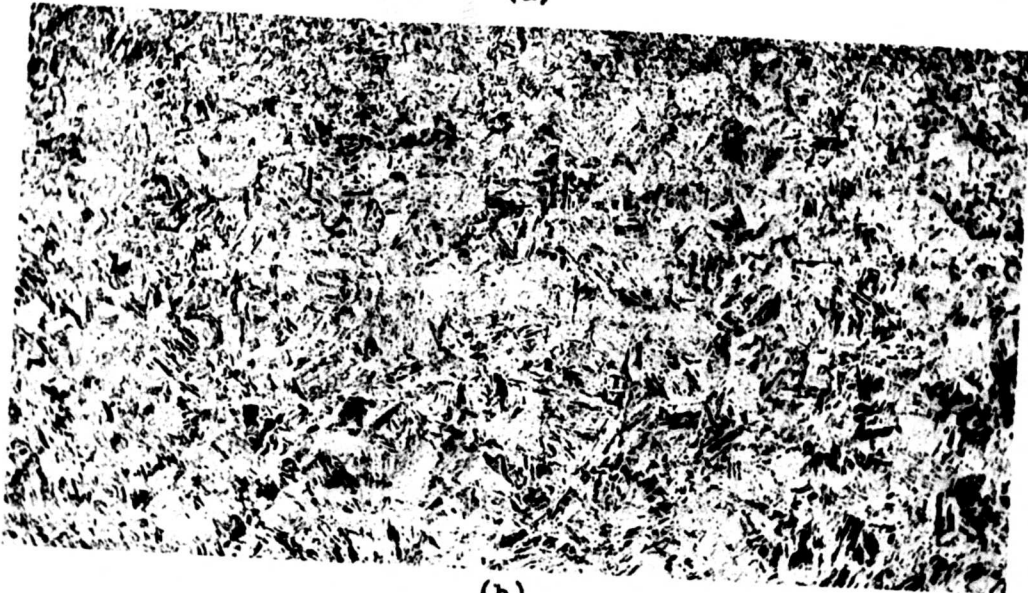
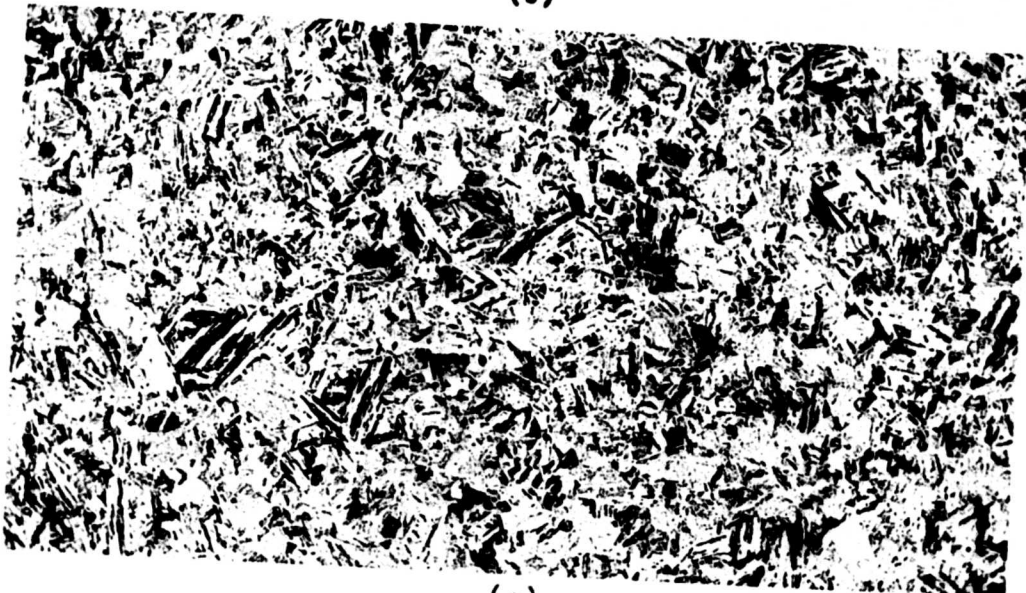
Figure 12

- a. Microstructure of junction between hard and soft layers at approximately the center of the junction zone.

3. Metallurgical examination indicated that the steel base was relatively free from nonmetallics and that with one exception, a gradual transition in microstructure was evident from the hard surface layer to the steel base. (See Figures 7a, 12, 14, 15, and 10b.)

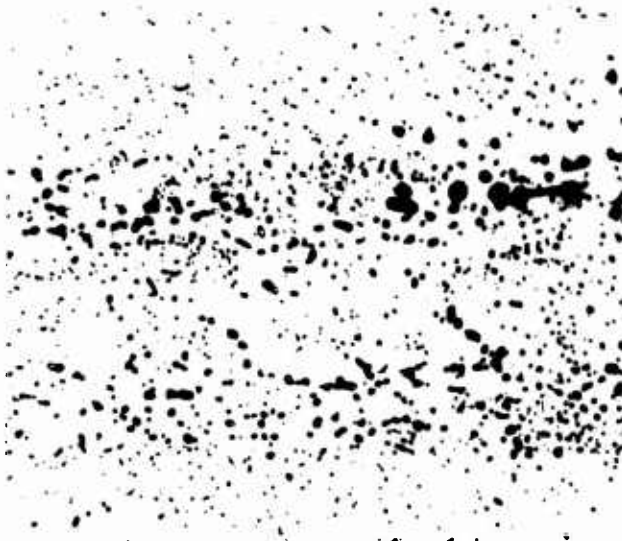
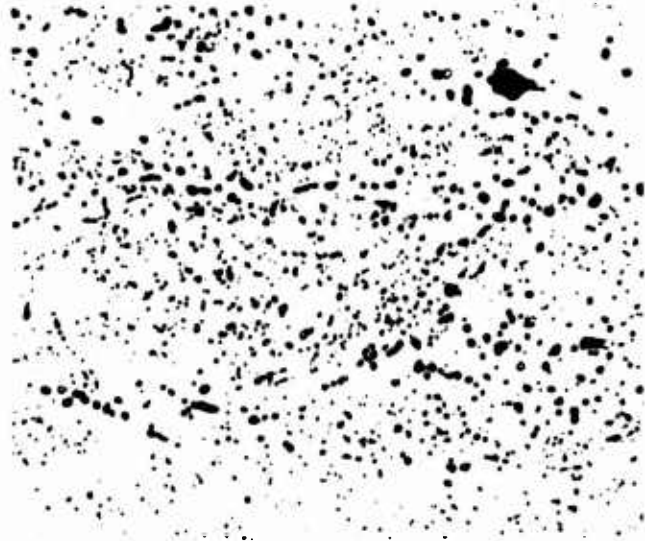
Figure 16
Microstructure

- c. Bands of carbide in hard surface layer.
Etched in Murakami's Reagent X250 MA-3416
- d. Bands of carbides in soft steel base of plate. The dark globules are etched delta ferrite.
Etched in Murakami's Reagent X250 MA-3417

d. Occasionally some grain boundary carbide was found in the steel base. (See Figures 16d, 17c, and 18d.)

AR30, AR35, AR36, and AR39. (See Figures 16a, c, and 16a.) The Murakami etch shows that there is a more complete solution of carbide in the surface layer of plates AR37 and AR38 than in the other samples. Some evidence of bands of carbide are present in the steel base of plate AR35. (See Figure 16d.)

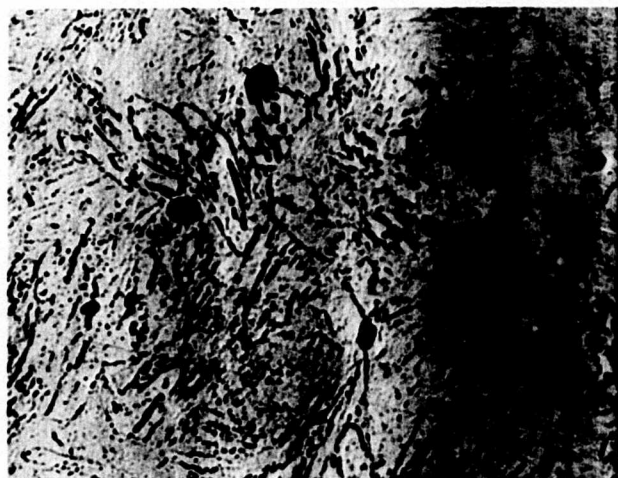
Figure 18Carbide Distribution

- a. Typical bands of carbides in the hard surface layer of AR39, including the prominent band which runs parallel to the plate surface, midway between the plate surface and center of the junction zone. The inclusion stringer which begins the inclusion-crack system occurs in the band. (The stringer has been attacked by the etch.) The carbide distribution in the hard surface layer of Plate AR36 is the same as illustrated by the photomicrograph.

- c. Typical grain boundary carbide found in the center of junction zone of hard surface and soft back of Plates AR36, AR37, AR38, and AR39.

- d. Typical microstructure of soft steel bases of Plates AR36, AR37, AR38, and AR39. Black globules are etched delta ferrite.

- e. Typical grain boundary carbide found in the hard surface layers of Plates AR37 and AR38.

Etched in Murakami's Reagent X1000 MA-3415

c. Some grain boundary carbide in the junction of the hard surface layer and the steel base. (See Figures 17b, and 18c.)

Fine grain boundary carbides are present in the low carbon layers of most of the plates as revealed by the Murakami reagent. (See Figures 17c and 18d.) Some prominent grain boundary carbide chains occur in the junction of the high and low carbon layers in plates AR35, AR36, AR37, AR38, and AR39. (See Figures 17b, and 18c.) Some medium size grain boundary carbides are present in this area in plate AR30. There are fine grain boundary carbides present in the hard surface layers of plates AR37, and AR38. Pronounced carbide bands are present in the high carbon face of plates

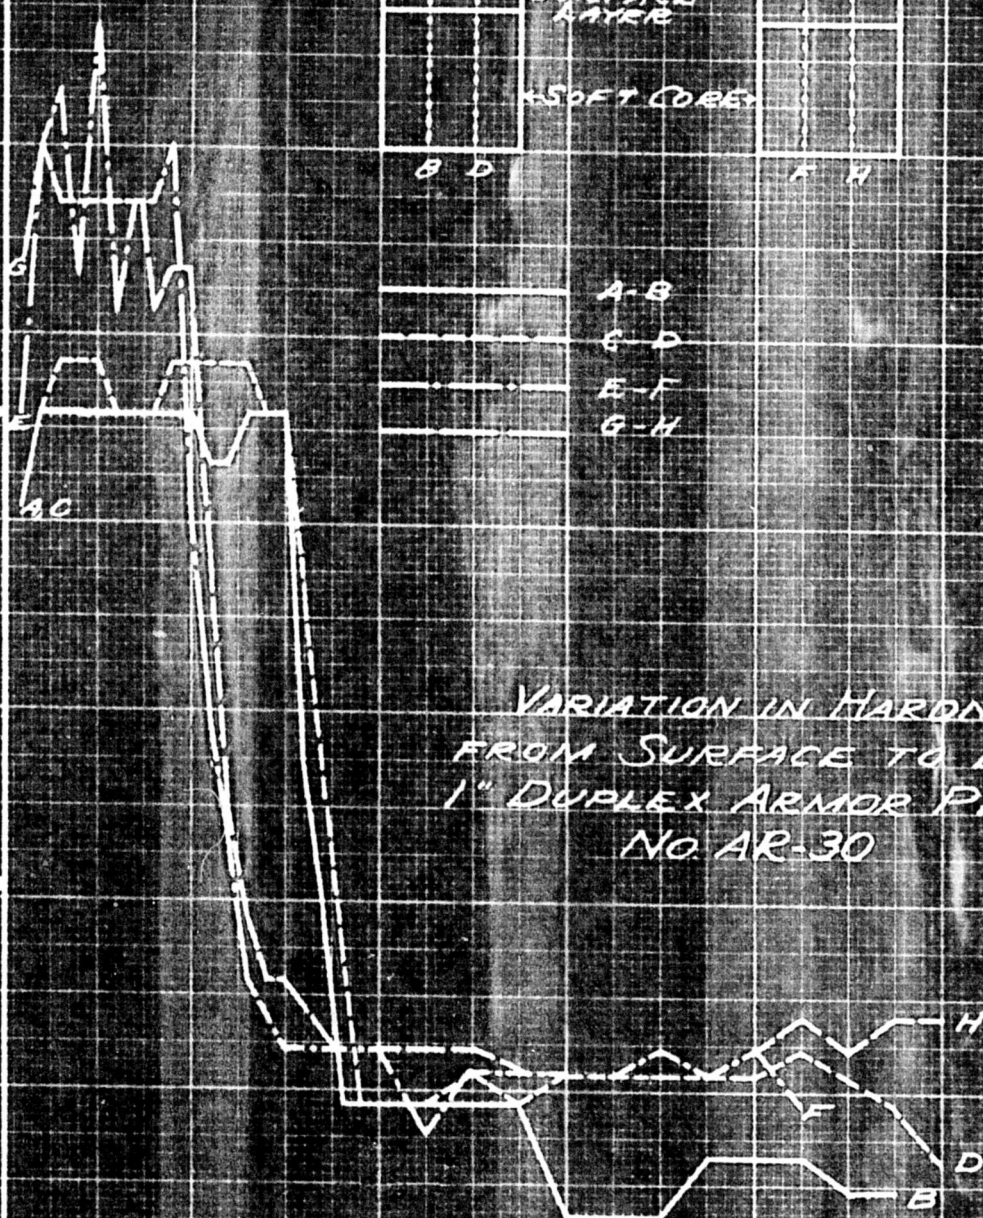
DEPTH IN INCHES

VICKERS BRINELL HARDNESS

HARD SURFACE LAYER

Vickers Brinell hardness surveys made on cross sections of the plates are shown in Figures 19-24 inclusive.
